**FINAL  
SITE INVESTIGATION  
NAVAL WEAPONS INDUSTRIAL  
RESERVE PLANT  
CALVERTON, NEW YORK  
NORTHERN AND CHESAPEAKE DIVISIONS  
VOLUME I**

**HALLIBURTON NUS  
ENVIRONMENTAL CORPORATION  
PITTSBURGH, PENNSYLVANIA**

**SITE INVESTIGATION REPORT**

**NAVAL WEAPONS INDUSTRIAL RESERVE PLANT**

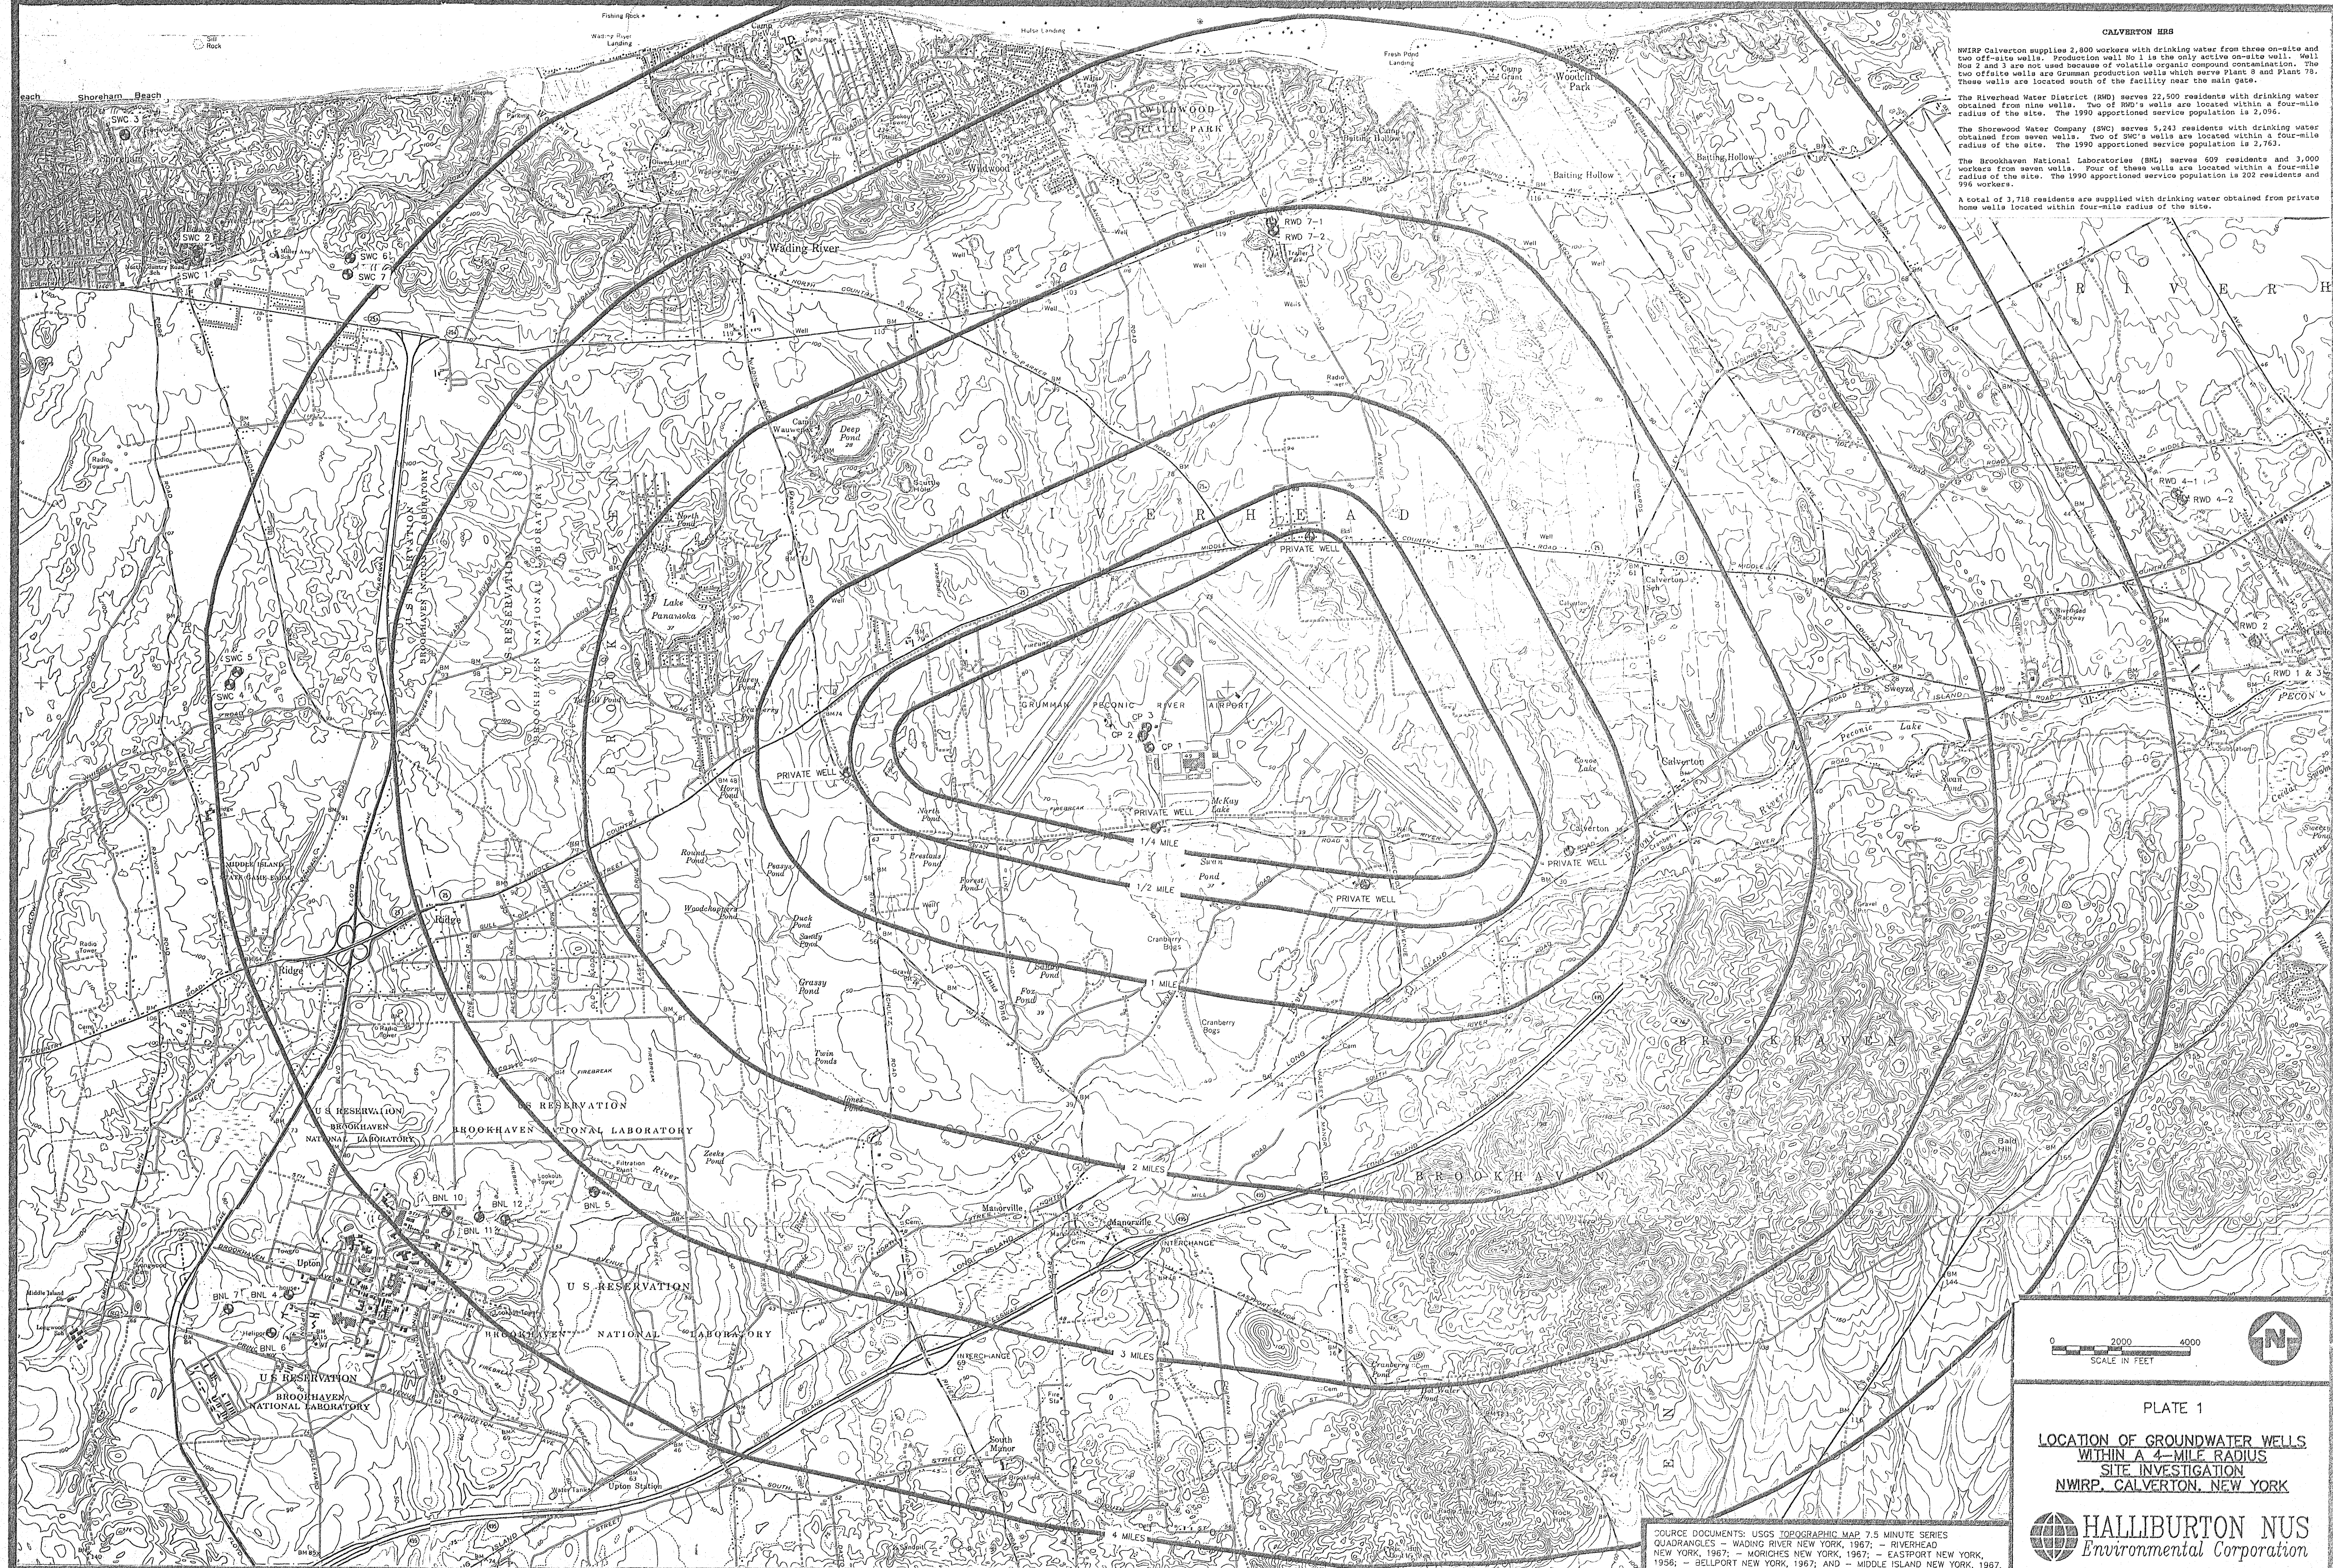
NWIRP Calverton supplies 2,800 workers with drinking water from three on-site and two off-site wells. Production well No. 1 is the only active on-site well. Wells No. 2 and 3 are not used because of volatile organic compound contamination. The two off-site wells are Grumman production wells which serve Plant 8 and Plant 78. These wells are located south of the facility near the main gate.

PLATE 1  
LOCATION OF GROUNDWATER WELLS  
WITHIN A 4-MILE RADIUS  
SITE INVESTIGATION  
NWIRP, CALVERTON, NEW YORK
